## Aircraft Vortices, Condensation and Contrails – an overview

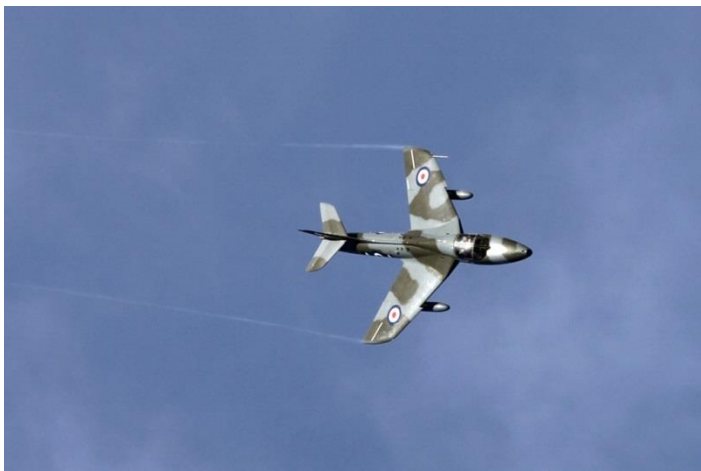
The pressure inside the rapidly-rotating vortex is reduced and, in humid conditions, may result in condensation making the tip vortex visible as a white trail from the wing tips. This is due to the local combination of temperature and pressure becoming lower than the 'dew point', resulting in visible condensation of water vapour from the atmosphere. This is visible in the photograph of the manoeuvring Hawker Hunter, above.

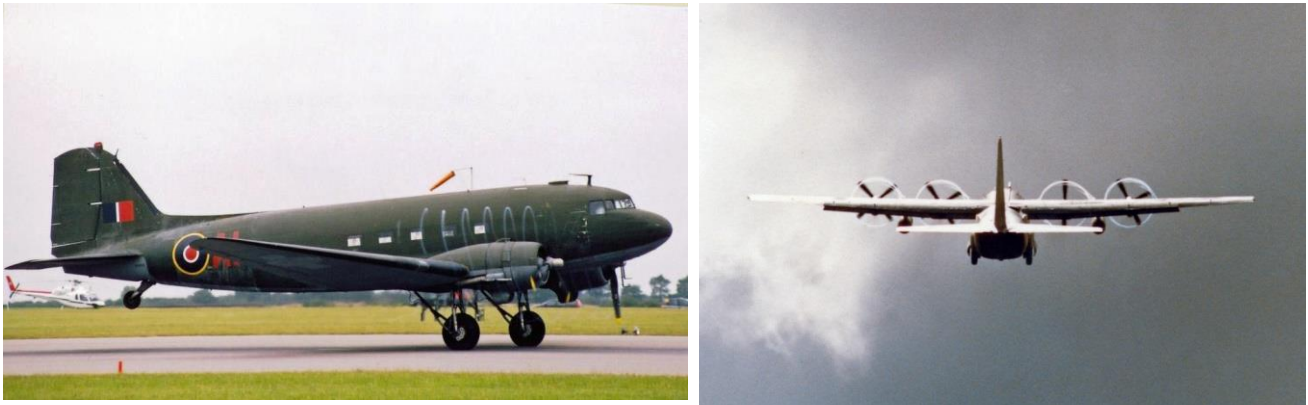
The tip vortex phenomena is not just restricted to the wing tip, but also occurs at the tips of heavily loaded propellers (and helicopter rotors) in suitable conditions, as illustrated below.

Above: Propeller tip vortices on a DC-3 and C-130 Hercules taking off

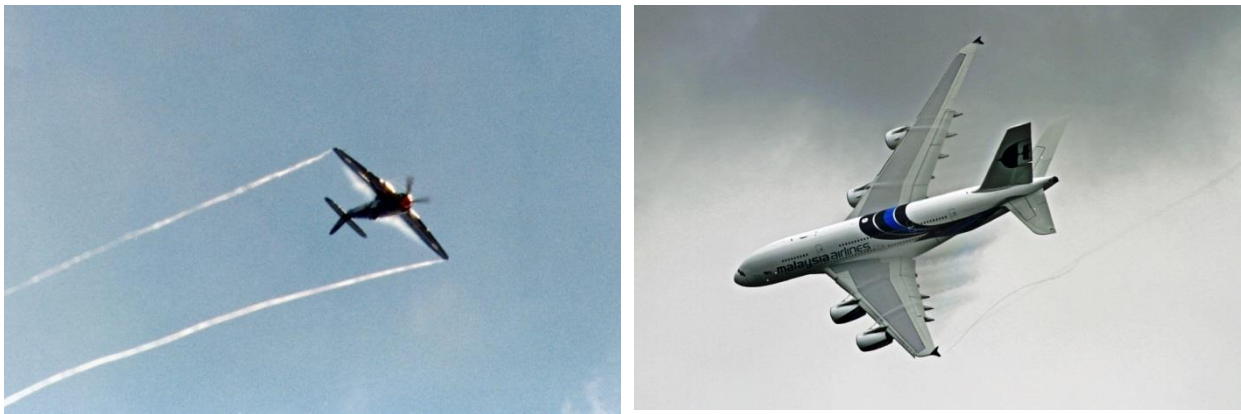
At high weights and when manoeuvring hard (pulling high-g) humid conditions may allow the general low pressure field above the wing to produce a visible 'cloud' of condensation above the wing. This is illustrated below with airshow pictures of a Hawker Sea Fury fighter and an Airbus A380 commercial transport aircraft.

Both aircraft are also trailing tip vortices and the Airbus also has vortices springing from small sharply swept plates fixed to the engine nacelles. These vortices help to maintain attached flow on the wing behind the engines, which would otherwise be disturbed at high incidence by the flows around the engine nacelles. Notice the condensation on the A380 trailing as a sheet behind the wing.

As the aircraft started to fly pass over an area of cloud, it started to produce a visible condensation cloud trailing behind the whole wing – as with the A380 illustrated earlier.

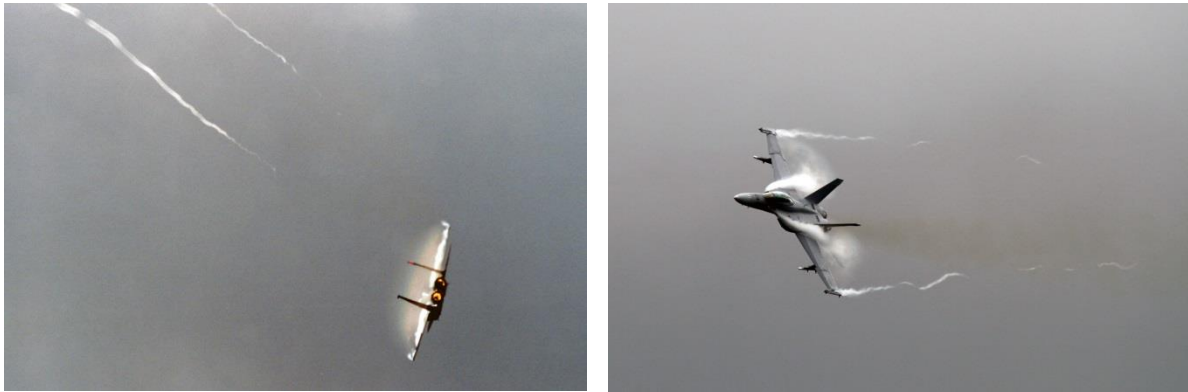
The two illustrations below show similar phenomena on modern jet fighters, the F-15 and F/A-18E.

Both aircraft are trailing tip vortices, which are noticeably 'wriggly' behind the aircraft. This distortion is caused by a phenomenon known as the 'Crow instability', which I don't propose to detail here (look it up on Wikipedia). Basically if one vortex is displaced up, or down it produces a lateral

displacement of the other vortex and far behind the aircraft this may cause the vortices to meet in a series of loops that dissipate their strength.

In the case of the F/A-18E (right), there is also a pair of very strong vortices sat above the aircraft wing roots. These are generated by a sharply-swept extension of the inboard wing leading edge (a strake), which produces this large vortex structure (with associated visible condensation) at high angles of attack. This is the same mechanism that is used to produce the vortices from the A380 engine nacelles.

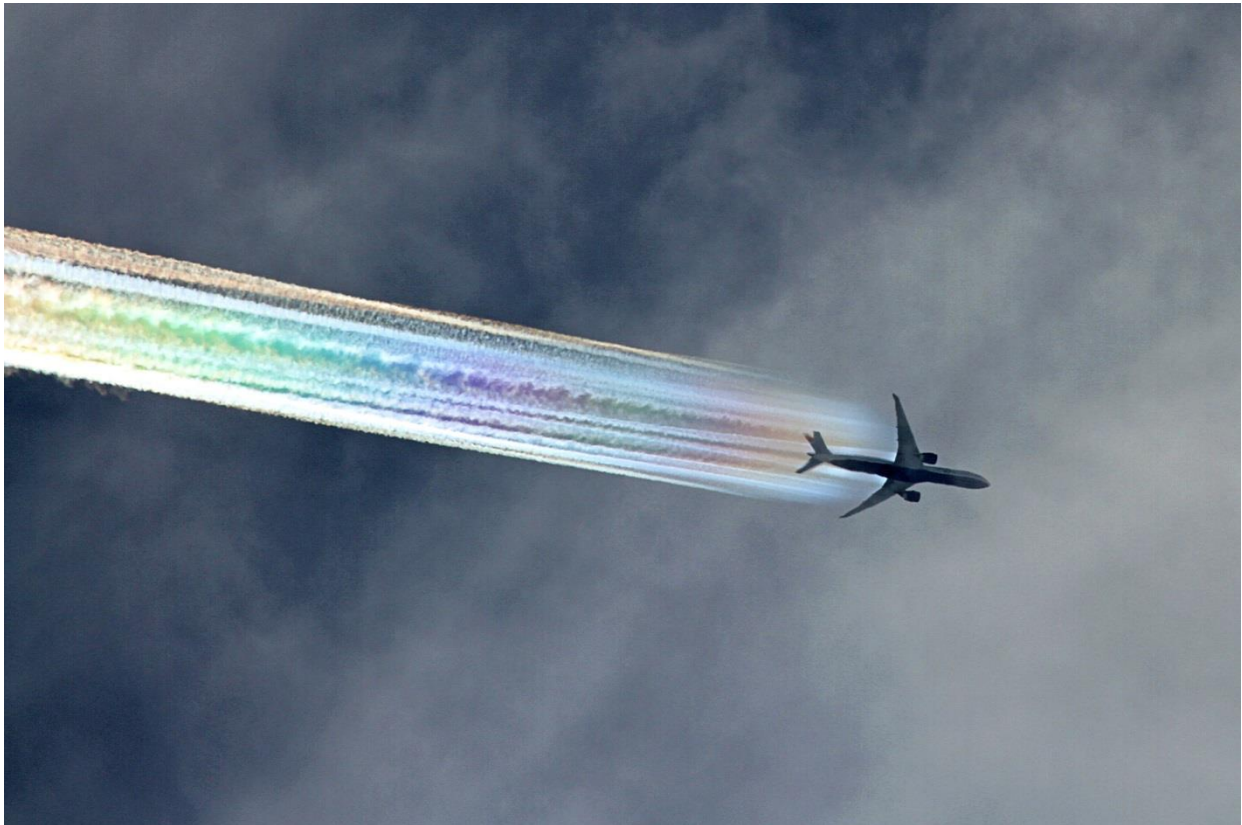
My last example is a rather beautiful 'rainbow' contrail behind a British Airways Boeing 777-300 airliner. This photograph was taken at around 1300 local on 18 July 2015 at Henstridge, Somerset, UK. The aircraft was flying from East to West and, when first seen, was only producing an intermittent contrail.

On examining the image, it can be seen that the particles in this contrail wake are interacting with the sunlight that is illuminating the wake to produce a dramatic rainbow effect in the contrail.
