## Aircraft Vortices, Condensation and Contrails – an overview

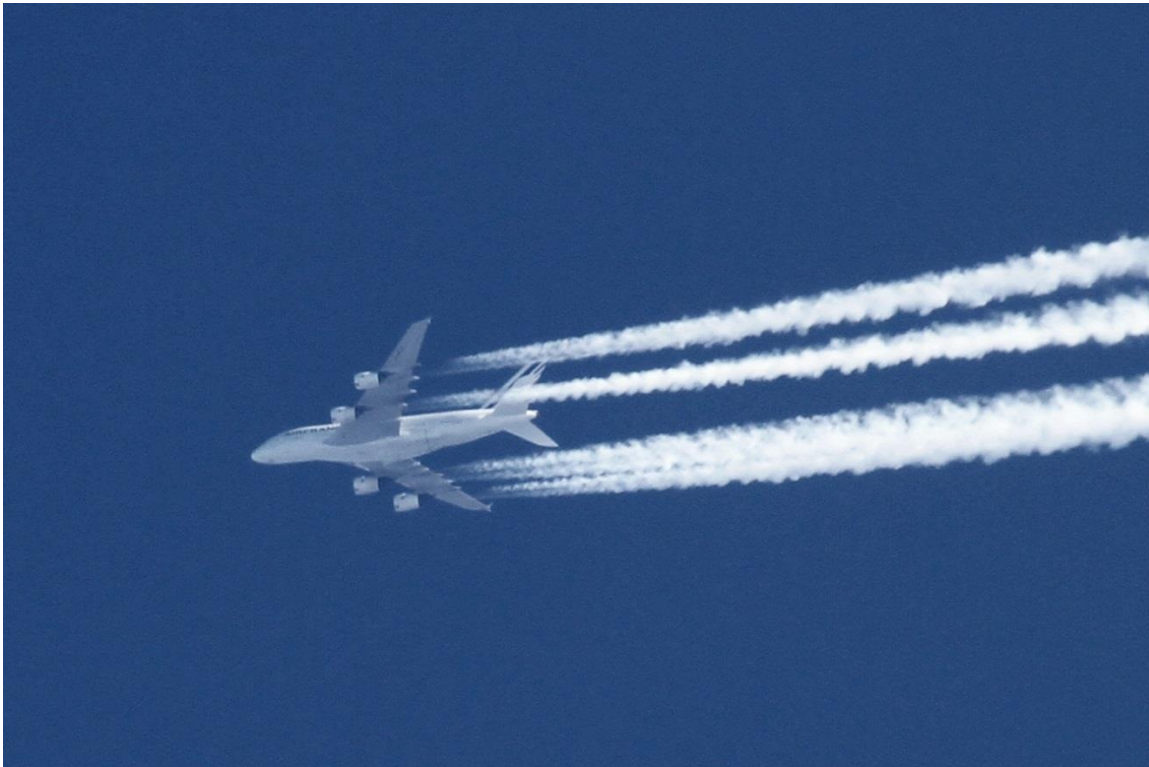
Perhaps the most common view of an airliner flying overhead is of a cruising aircraft at altitude with white trails being left behind in the sky tracing its path.

These trails are known as contrails and are a result of water vapour, produced as a product of combustion, being ejected from the aircraft engines. This phenomena was first observed and widely commented on as a result of high altitude combat between fighters and bombers during the Second World War. This reflects that the conventional aircraft piston engine also produces water vapour in its exhaust and is equally capable of producing a contrail in high altitude flight.

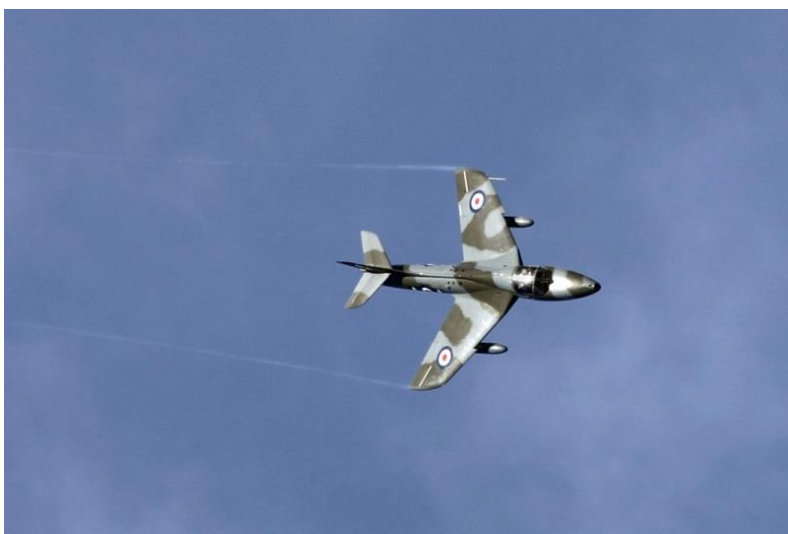
The pressure inside the rapidly-rotating vortex is reduced and, in humid conditions, may result in condensation making the tip vortex visible as a white trail from the wing tips. This is due to the local combination of temperature and pressure becoming lower than the 'dew point', resulting in visible condensation of water vapour from the atmosphere. This is visible in the photograph of the manoeuvring Hawker Hunter, above.

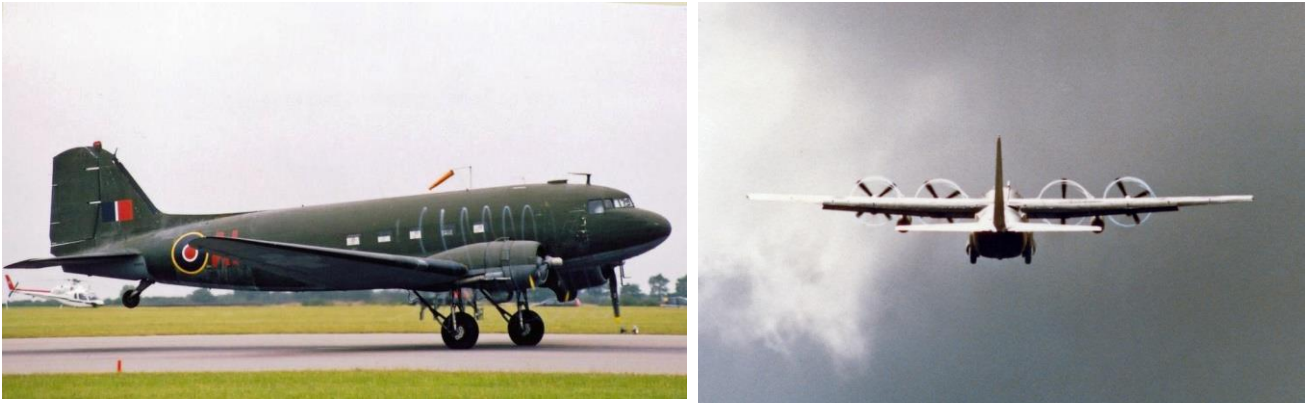
The tip vortex phenomena is not just restricted to the wing tip, but also occurs at the tips of heavily loaded propellers (and helicopter rotors) in suitable conditions, as illustrated below.

Above: Propeller tip vortices on a DC-3 and C-130 Hercules taking off

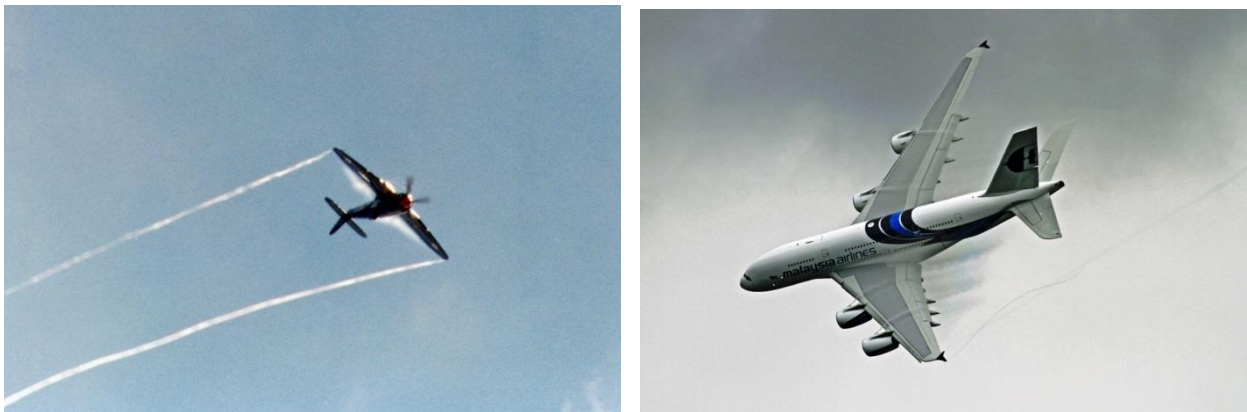
At high weights and when manoeuvring hard (pulling high-g) humid conditions may allow the general low pressure field above the wing to produce a visible 'cloud' of condensation above the wing. This is illustrated below with airshow pictures of a Hawker Sea Fury fighter and an Airbus A380 commercial transport aircraft.

Both aircraft are also trailing tip vortices and the Airbus also has vortices springing from small sharply swept plates fixed to the engine nacelles. These vortices help to maintain attached flow on the wing behind the engines, which would otherwise be disturbed at high incidence by the flows around the engine nacelles. Notice the condensation on the A380 trailing as a sheet behind the wing.

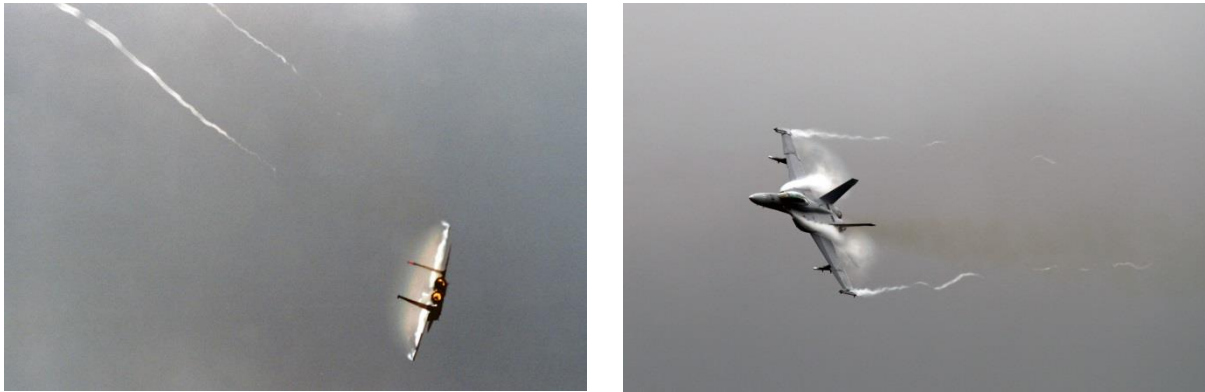
The two illustrations below show similar phenomena on modern jet fighters, the F-15 and F/A-18E.

In the case of the F/A-18E (right), there is also a pair of very strong vortices sat above the aircraft wing roots. These are generated by a sharply-swept extension of the inboard wing leading edge (a strake), which produces this large vortex structure (with associated visible condensation) at high angles of attack. This is the same mechanism that is used to produce the vortices from the A380 engine nacelles.

The large vortex structure generates suction over the wing, allowing lift to be generated at high angles of attack at which the wing would normally stall and increasing the aircrafts manoeuvre capability. The same mechanism was used to provide the majority of the low speed lift for Concorde and resulted in the high nose up attitude of that aircraft when on the landing approach.

Both aircraft are trailing tip vortices, which are noticeably 'wiggly' behind the aircraft. This distortion is caused by a phenomenon known as the 'Crow instability', which I don't propose to detail here (look it up on Wikipedia). Basically if one vortex is displaced up, or down it produces a lateral displacement of the other vortex and far behind the aircraft this may cause the vortices to meet in a series of loops that dissipate their strength. The photo below is an example of the Crow instability in the contrail of a Boeing 747, well behind the aircraft.

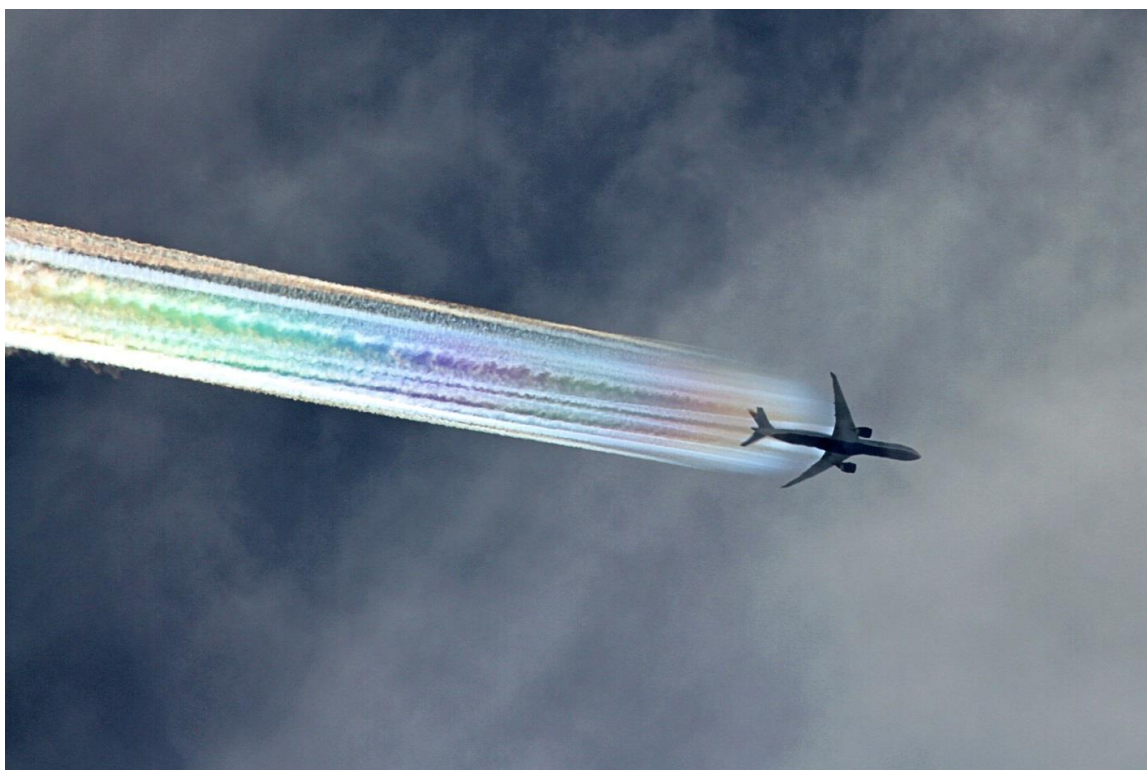
My last example is a rather beautiful 'rainbow' contrail behind a British Airways Boeing 777-300 airliner. This photograph was taken at around 1300 local on 18 July 2015 at Henstridge, Somerset, UK. The aircraft was flying from East to West and, when first seen, was only producing an intermittent contrail. As the aircraft started to fly pass over an area of cloud, it started to produce a visible condensation cloud trailing behind the whole wing – as with the A380 illustrated earlier.

On examining the image, it can be seen that the particles in this contrail wake are interacting with the sunlight that is illuminating the wake to produce a dramatic rainbow effect in the contrail.
